Manhole Inspection Summary

Manhole # S35II_018MH

Insp Date: **3/13/07 1:00 PM**

Location Address: **21 LANVALE ST**

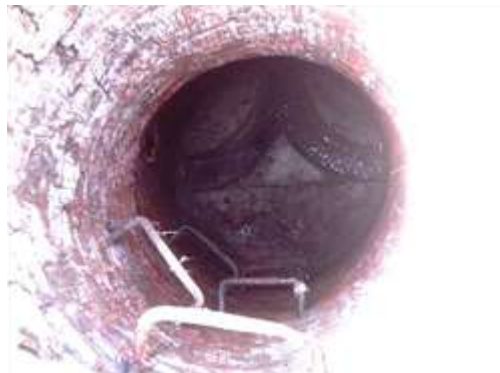
Top View

Corroded steps. Bench debris.

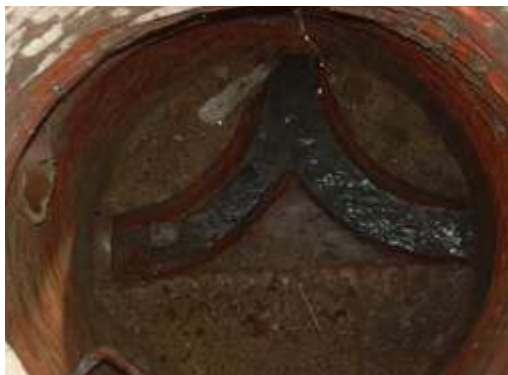
Top View

Corroded steps. Bench debris

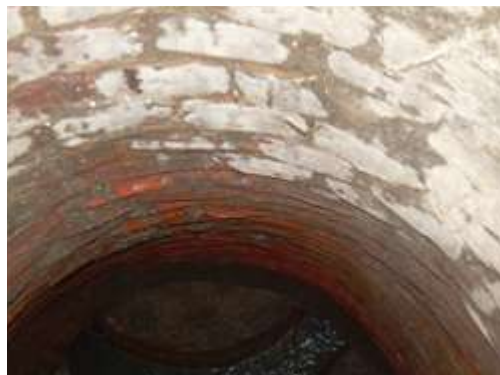
Defect

Adjustment, Corbel and Barrel infiltration.

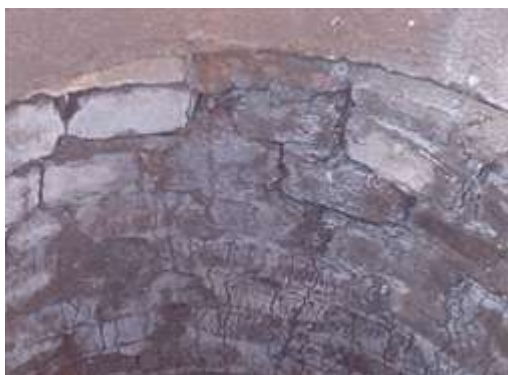
Defect

Frame leaks. Adjustment and Corbel deterioration and infiltration.

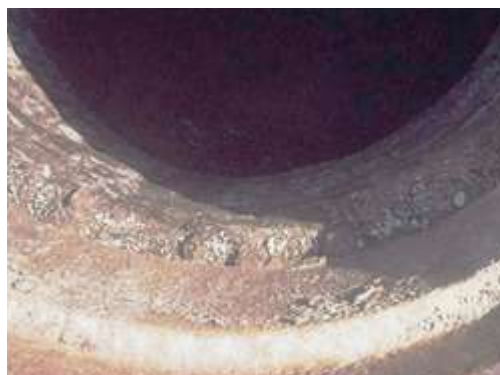
Defect

Frame leaks. Frame offset.

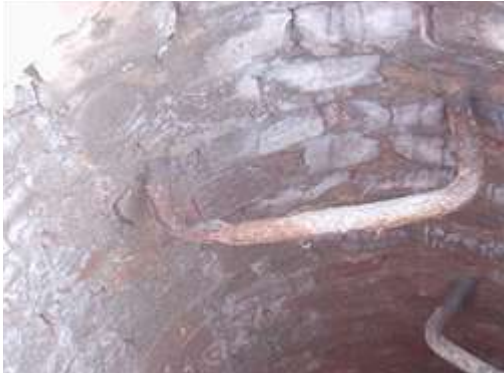
Defect

Adjustment and Corbel deterioration and infiltration.

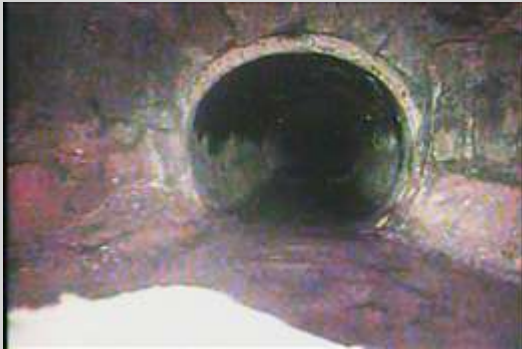
8 in. Circular Gravity Sewer Pipe Out @ 12 O'Clock

Infiltration: **Evidence** Pipe Seal Cond: **Unknown**

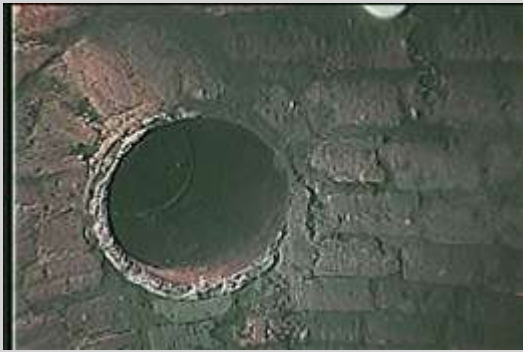
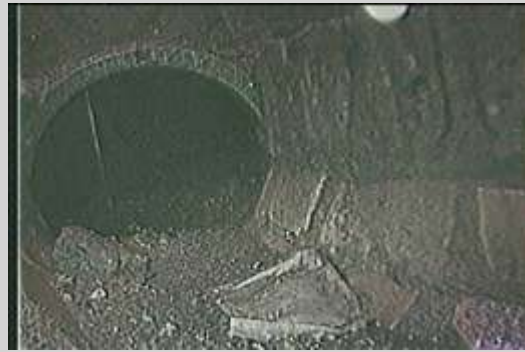
Pipe In @ 9 O'Clock

Deposits: ☐ None ☒ **Mud** ☐ Sludge ☒ **Debris** ☐ Grease

Deposits Extent: **Light**

Infiltration: **Evidence**

Pipe Seal Cond: **Cracked**
